# Manhole Inspection Summary

Manhole # S45K\_\_014MH

Insp Date: **4/30/08 2:19 PM**

**Location** Address: **1820 s wolfe st**

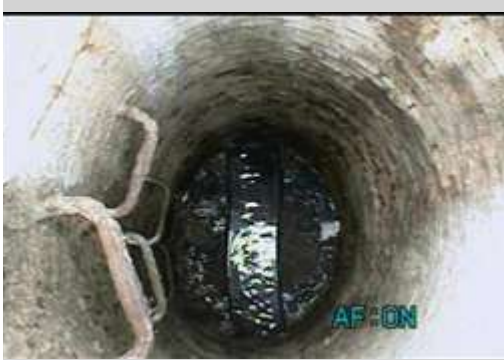
Defect 1

**Steps** Count: **8** Missing: **0** ☒ **Corroded**

Corroded Steps

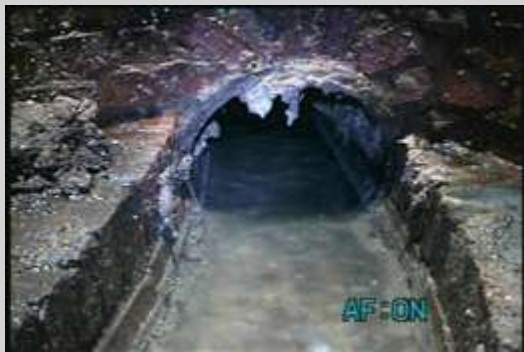
12 O'Clock Outflow

12 in. Circular Gravity Sewer  
Pipe Out @ 12 O'Clock

Pipe Material: **Clay** ☐ Pipe Lined

Invert Depth: **12.58** (ft.) Flow Characteristics: **Fast**

Infiltration: **None** Pipe Seal Cond: **Unknown**

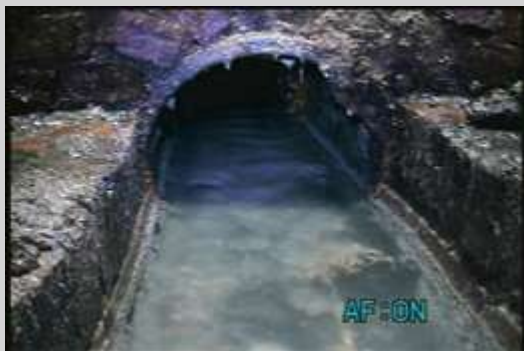
6 O'Clock Inflow

12 in. Circular Gravity Sewer  
Pipe In @ 6 O'Clock

Pipe Material: **Clay** ☐ Pipe Lined

Invert Depth: **12.50** (ft.) Flow Characteristics: **Fast**

Infiltration: **None** Pipe Seal Cond: **Unknown**
